THEA FOSS AND WHEELER-OSGOOD WATERWAYS REMEDiation PROJECT

YEAR 6 MONITORING

ANNUAL OPERATIONS, MAINTENANCE, AND MONITORING REPORT

OCTOBER 3, 2012

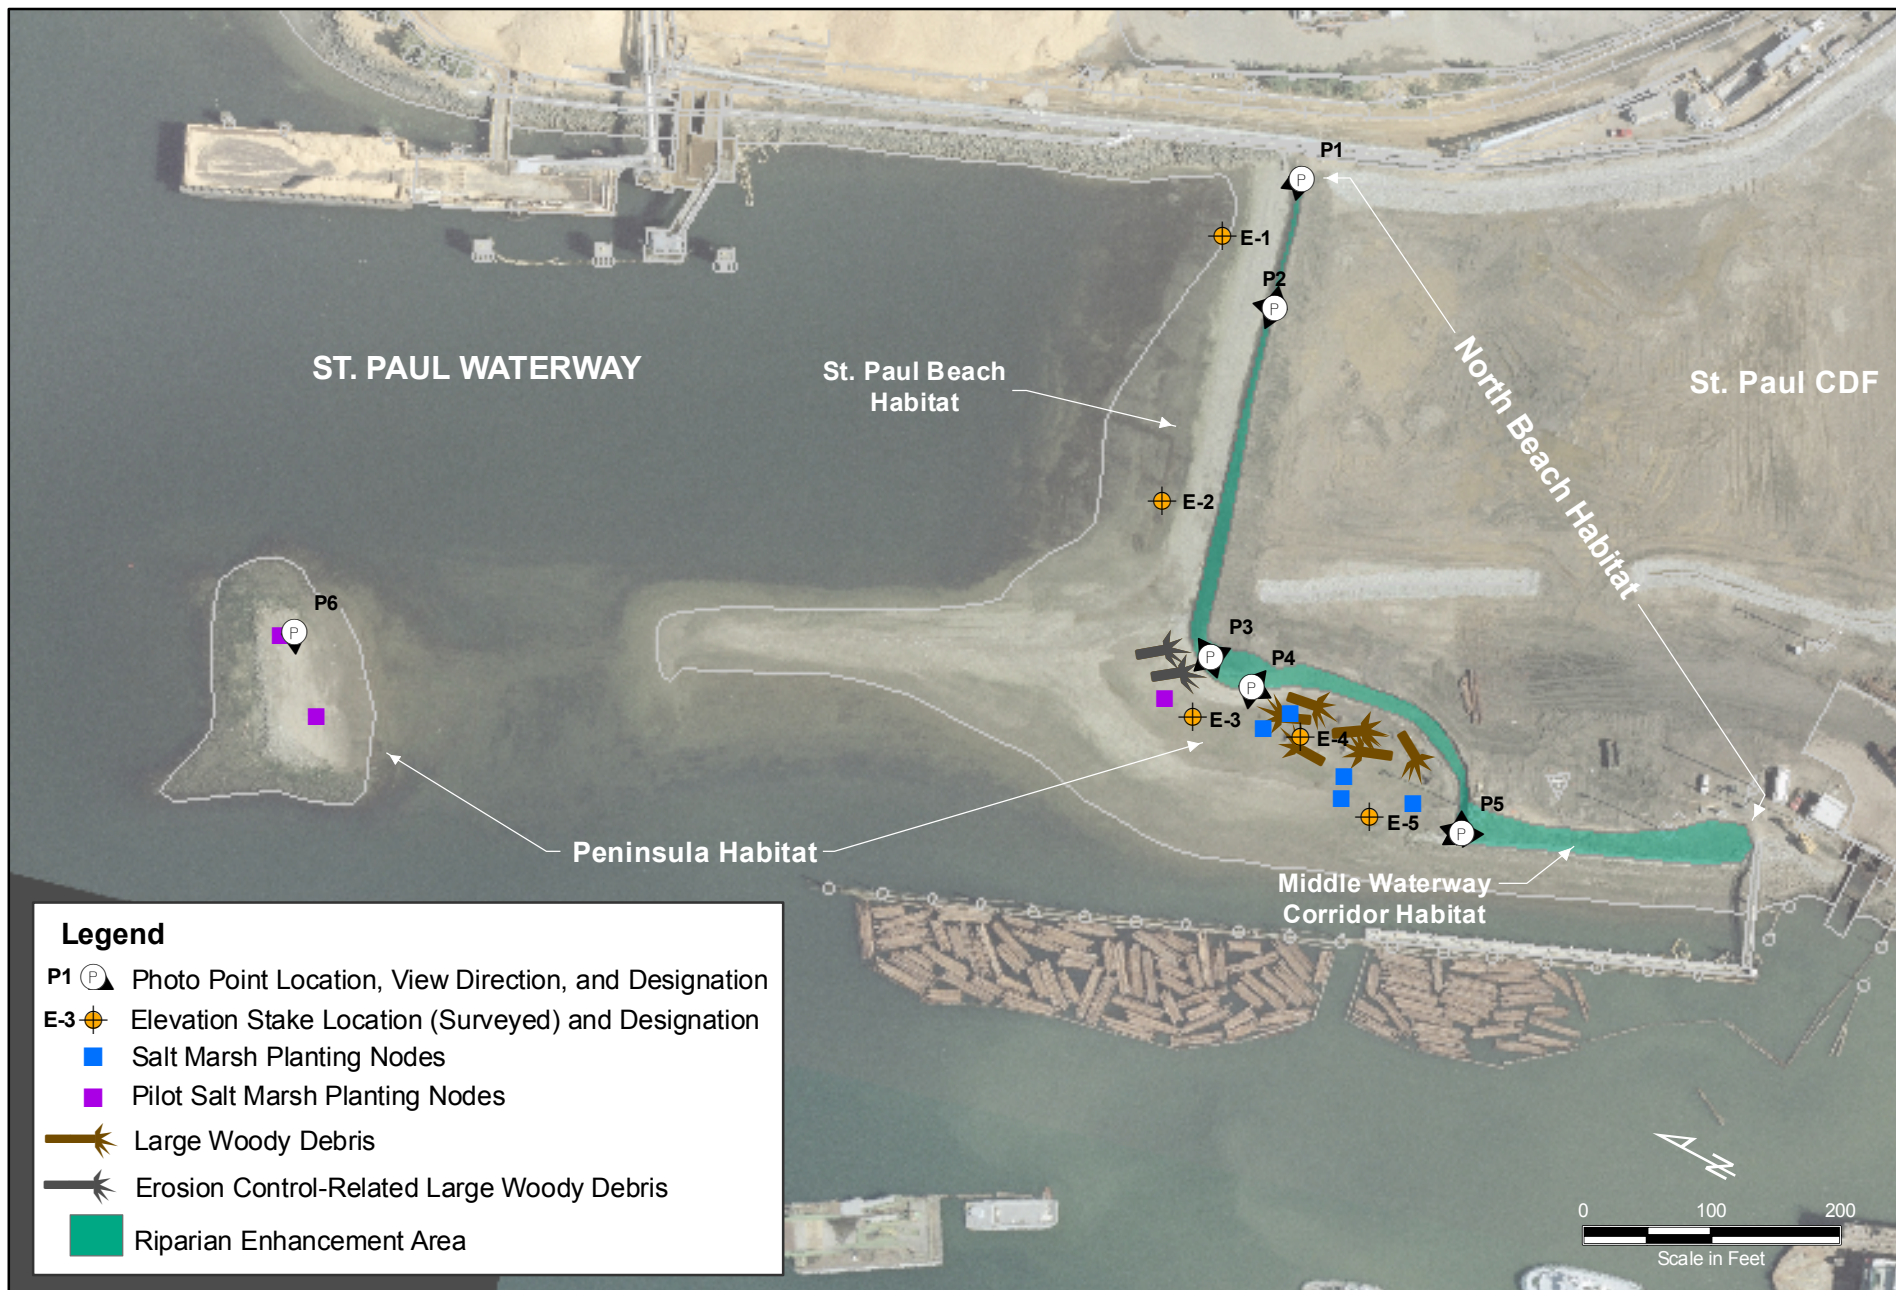
**Figure 6-1
North Beach Habitat**

Qualitative Ground Survey – The qualitative ground survey at this site was conducted on July 19, 2012. A copy of the completed field form can be found in Attachment E-1. Overall, the site was noted to be in good condition. Upon arrival, there were two eagles, Canada Geese, seagulls, a great blue heron, crows, Caspian terns, a moon snail and bees observed at the site. No significant amount of erosion was identified, with the exception of the toe of the slope of the containment berm where it meets the habitat beach, which is discussed below. Dynamic beach conditions led to some sediment accumulation in some areas and a push of gravel on the outer

portion of the cutback area. There were no indications of animal damage or vandalism found, and very minimal amounts of trash and wrack associated with the tideline. There was no indication of vegetative disease observed. Most of the LWD in the potential marsh area need to have their anchors tightened in place again or need to be replaced. The LWD are moving around and appear to be causing some impacts to plant success, location and density in the potential marsh area. There are still five pieces of LWD present in this area of the six that were initially installed.

There was no change noted in the appearance of the surface soils in the riparian or aquatic areas relative to previous monitoring events. There was no indication of odor or sheen in either area. Overall, there was no apparent site disturbance and no follow-up actions were needed.

Habitat mix/fine-grained material was present at the surface of the upper intertidal area in depths similar to previous observations. Through probing of this material, it was found that the depth of fine-grained material ranged from approximately three inches at the east end of the beach to more than twelve inches present near the peninsula at the northwest corner of the site. The beach substrate is continuing to shift and grade.

There is still no volunteer vegetation on the island. It appears that the conditions are not favorable for plant establishment in this area.

Site	Corrective Action Tasks
North Beach Habitat	<ul style="list-style-type: none"> - minor weeding / trash removal - tighten/replace anchors on large woody debris - mulch around plants in newer riparian area
Middle Waterway Tideflat Habitat	<ul style="list-style-type: none"> - repair/replace sprinkler heads as needed - minor weeding / trash removal - check large woody debris anchors and tighten anchors as needed
Puyallup River Side Channel	<ul style="list-style-type: none"> - minor weeding / trash removal
Hylebos Creek Mitigation Site	<ul style="list-style-type: none"> - minor weeding / trash removal - check large woody debris anchors and tighten anchors as needed
Johnny's Dock Habitat Enhancement	<ul style="list-style-type: none"> - minor weeding / trash removal - check large woody debris anchors and tighten anchors as needed
Head of Thea Foss Shoreline Habitat	<ul style="list-style-type: none"> - minor weeding / trash removal - check large woody debris anchors and tighten anchors as needed

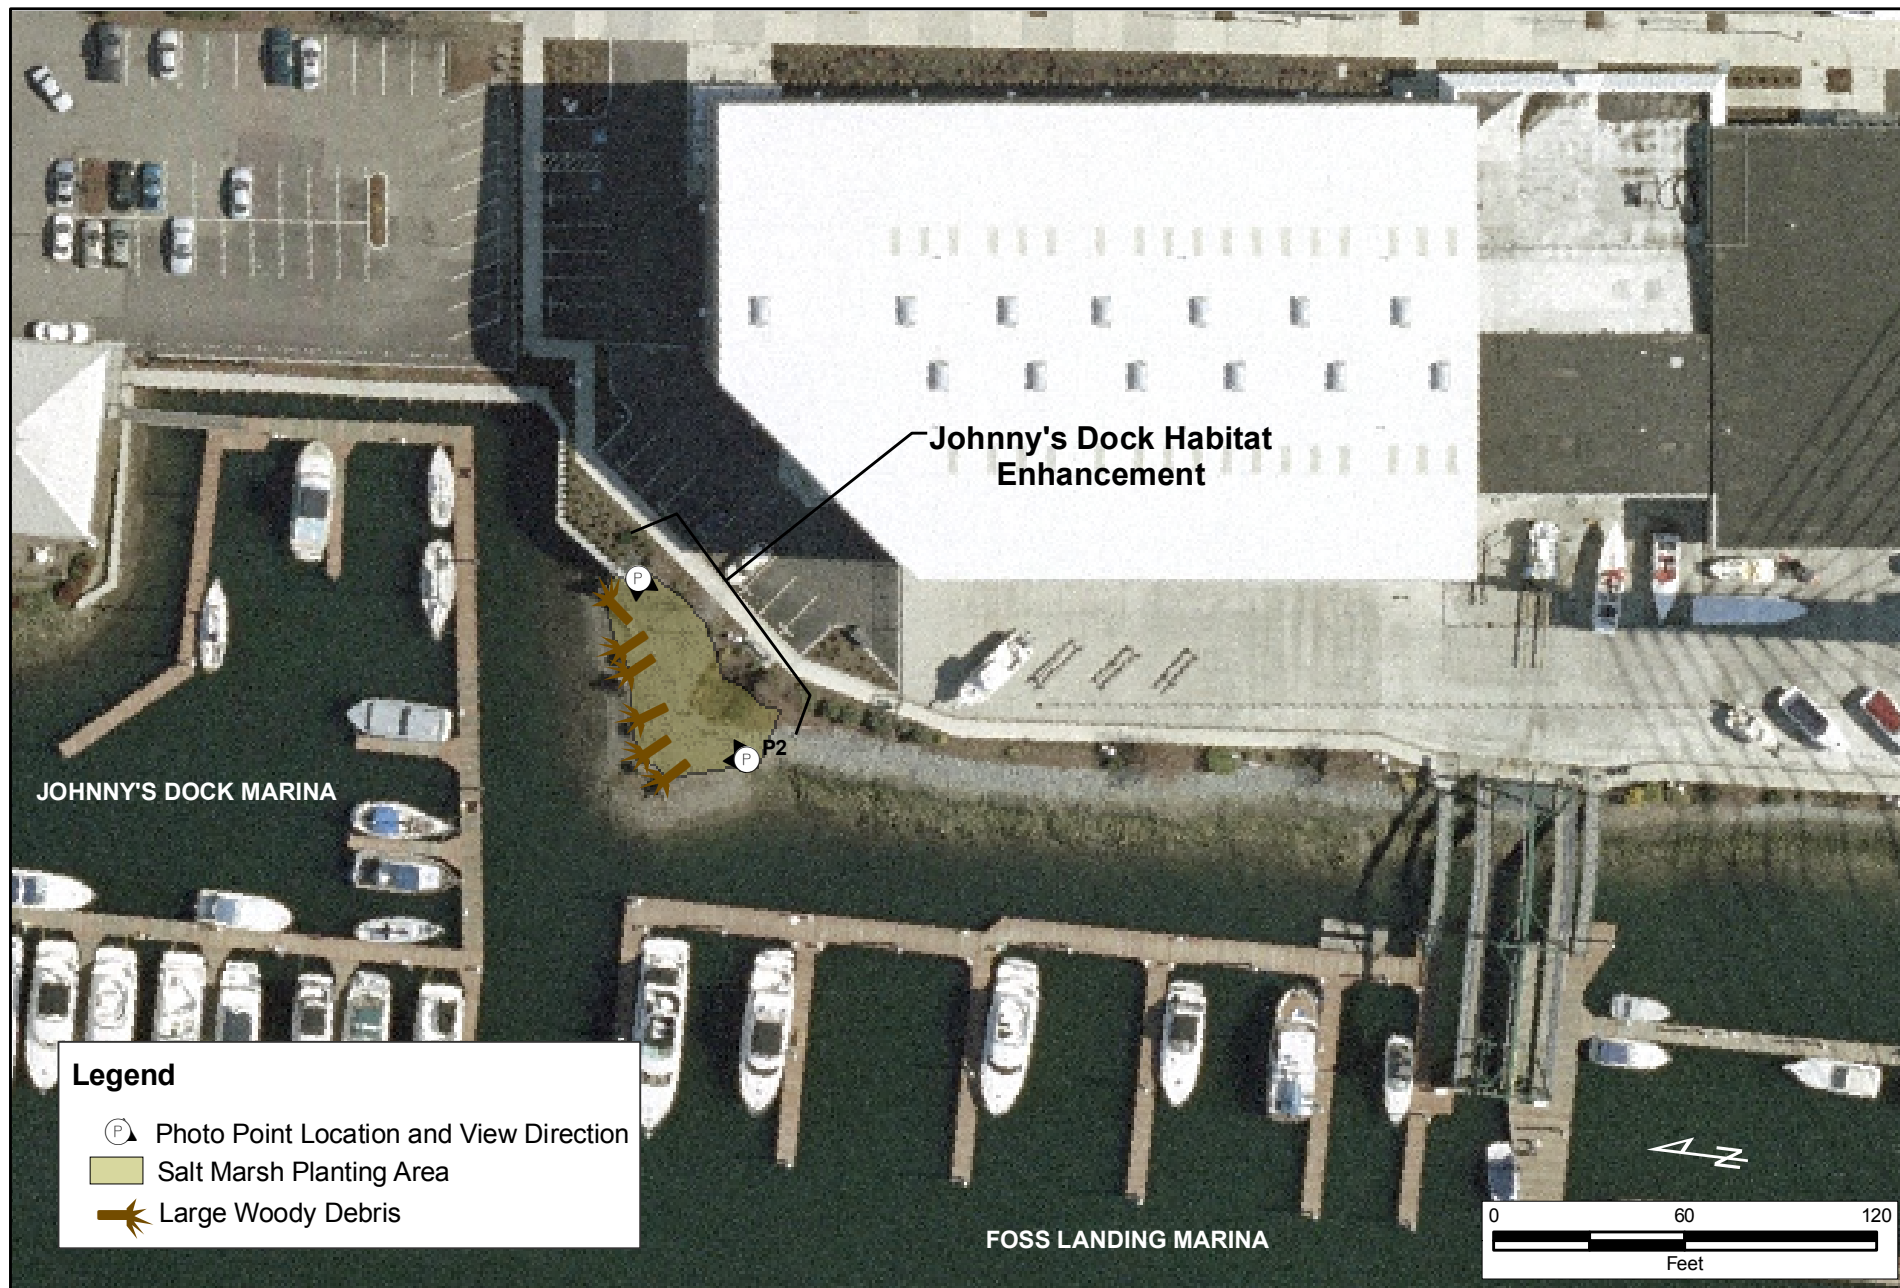
**Figure 6-5
Johnny's Dock Habitat Enhancement**

Johnny's Dock Habitat Enhancement – This area is a pocket beach constructed to enhance the habitat between the Foss Landing and Johnny's Dock Marinas (see Figure 6-5). Prior to remediation, an old timber access pier with a brick foundation was present at the site. As part of construction of this habitat area, this structure was removed from the marine environment. A thick quarry spall cap consisting of an 18-inch deep layer of filter material overlain by an 18-inch deep layer of quarry spalls was then placed. Habitat mix was placed on the slope over the quarry spalls between elevations -10 feet MLLW and 13 feet MLLW. Saltmarsh vegetation was planted between 10 feet MLLW and 13 feet MLLW, and LWD was added to the slope to add complexity to the habitat feature. A goose exclusion grid was installed to minimize herbivory but has since been removed.

Qualitative Ground Survey – The qualitative ground survey at this site was conducted on July 19, 2012. A copy of the completed field form can be found in Attachment E-1. Overall, the site was noted to be in fair condition. Upon arrival at the site geese and a goldfinch were present. No significant erosion or sedimentation were identified. Extensive goose predation on the grasses was noted, but there were no indications of disease, vandalism, trash or wrack present. The goose exclusion grid has been removed and the LWD was found to be present and in good condition.

The onsite soils were observed to be unchanged from the last monitoring event. The surface soils are grey, gravelly sand habitat mix. There was no indication of odor or sheen. Overall, there was no apparent site disturbance and no follow-up actions were needed.

The site had been planted in accordance with the approved planting plans. A combination of pickleweed and saltgrass were planted between elevations 10 feet MLLW and 12 feet MLLW. Tufted hairgrass had been planted above that, between 12 feet MLLW and 13 feet MLLW. *Distichlis spicata* is the dominant species at the site, but it continues to be grazed significantly by the geese. One pickleweed plant and only a few tufted hairgrass plants were observed during this monitoring event. Some volunteer gumweed was present along with goose tongue and native blackberry. There were no invasive species identified during the inspection.

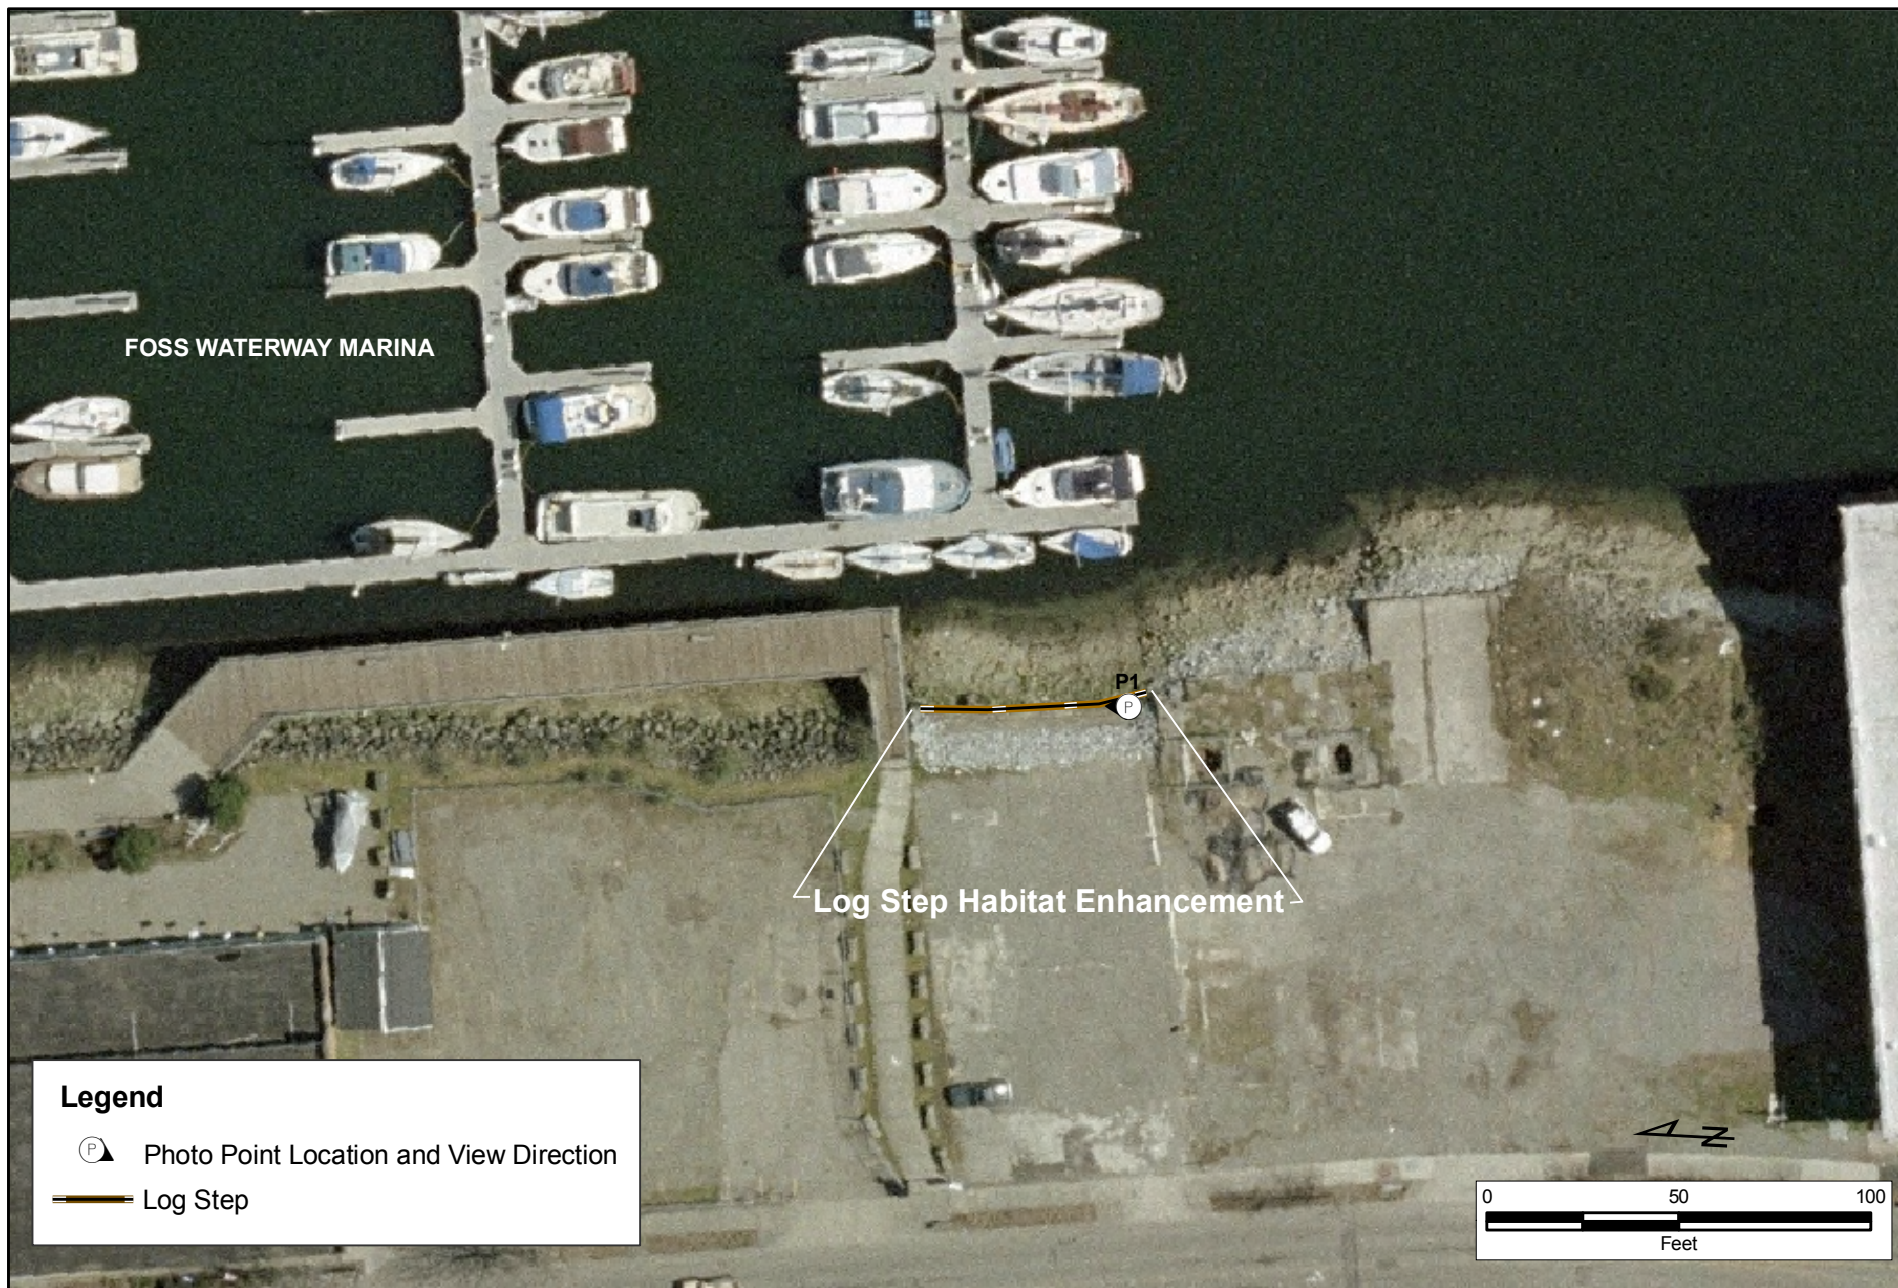
Figure 6-8
Log Step Habitat Enhancement

Log Step Habitat Enhancement – Approximately 35 treated timber piling, a 12- by 14-foot concrete vault, and other debris were removed from an area on the west side of the waterway between the Colonial Fruit warehouse and the Foss Harbor Marina. A portion of the area was dredged, and a thick quarry spall cap consisting of 18 inches of filter material overlain by 18 inches of riprap was constructed. Habitat mix was placed over the area between the elevations of -10 feet MLLW and 11 feet MLLW (see Figure 6-8).

A 2-step log transition was constructed between elevations 11 feet MLLW and 13 feet MLLW and a 3-foot bench was constructed using 18 inches of filter material overlain with an 18-inch deep layer of quarry spalls. Habitat mix was placed over the quarry spalls, and saltmarsh grasses planted at elevation 13 feet MLLW along the 65-foot long high intertidal bench.

Qualitative Ground Survey – The qualitative ground survey at this site was conducted on July 19, 2012. A copy of the completed field form can be found in Attachment E-1. Overall, the site was noted to be in excellent condition. Upon arrival, there were pigeons and seagulls observed off-site, but no wildlife found present at the site itself. No sedimentation was identified at the site and only a minor amount of erosion from the area covering the outfall. There were no indications of animal damage, disease, trash, or vandalism. The log step appeared to be in good condition and only minor maintenance, including checking the anchors on the logs, is needed.

There was no change in the surface soils noted at the site and there was no indication of odor or sheen. Overall, there was no apparent site disturbance and no deficiencies in soil conditions were identified.

The site had been planted in accordance with the approved planting plans. A combination of American dunegrass and tufted hairgrass was planted in a 3-foot wide bench behind the log step at an elevation of approximately 13 feet MLLW. It was noted during the inspection that the dunegrass was continuing to do very well and is clearly the dominant species at the site. There was no tufted hairgrass observed. Pickleweed, gumweed and orache are volunteering at the site. Some invasive species are present adjacent to the site including St. John's Wort and a cherry tree. Therefore, only minor weeding is needed.
